## PROBABILISTIC AND DIAGNOSTIC METHODS TO DETERMINE THE MULTIPLE FAILURE MECHANISMS OF HPT 1<sup>ST</sup> STAGE MARINE GAS TURBINE BLADE.

The failure analysis of high pressure turbine (HPT) blade belonging to 30 MW gas turbine used in marine applications is presented. Before failure, the turbine blade under evaluation was operated for about 10000 hours while its service life was expected to be around 15000 hours. The gas turbine blade was made of Nickel based super alloy and was manufactured by investment casting method. An attempt has been made to analyze the causes and modes of failure of a gas turbine blade. During operation, the turbine blade is subjected to large centrifugal forces and operated at elevated temperatures in corrosive environmental attack such as oxidation, hot corrosion and sulphidation etc. The investigation includes the activities like visual inspection, determination of material composition, microscopic examination, metallurgical analysis and Mechanical analysis. Metallurgical examination was carried out to diagnose the possible causes of blade failure of micro structural damage due to blade operation at elevated temperatures. The thermal-structural finite

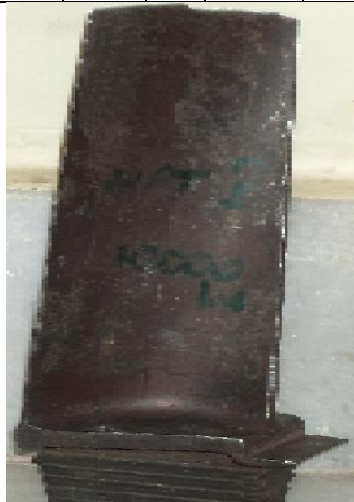
Fig. 3: High pressure temperature (HPT) 1<sup>st</sup> stage gas turbine blade.

under evaluation were the first stage blade of a 30 MW gas turbine engine used for marine application with a turbine gas inlet temperature of around 950°C. It was observed that the blades were damaged during periodic service.

The failed HPT gas turbine blade was presented in figure 3. The blade that had operated for about 10000 hrs before its failure was made of Ni-based super alloy. As a part of investigation on the gas turbine blade, the following activities have been carried out to know the causes of blade failures.

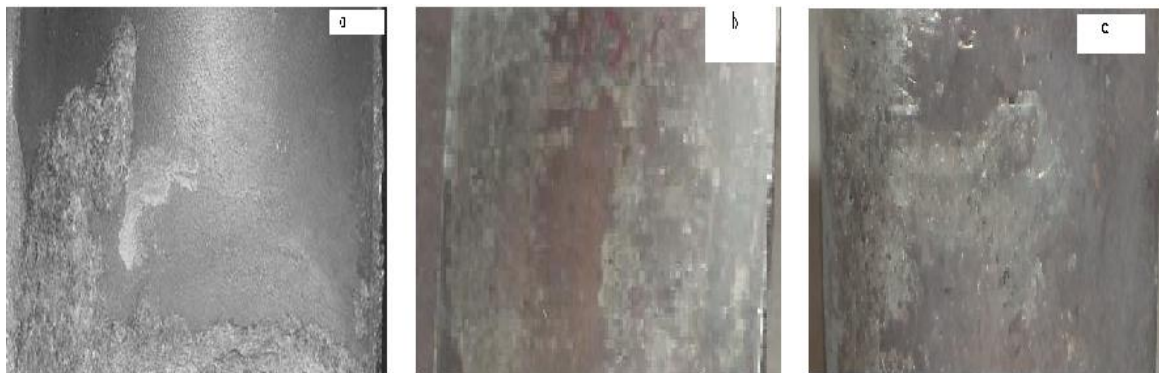
The macroscopic features of the turbine blade were observed by visual examination. Very rough surface was noticed in the region, close to the root of the blade, and exhibited some colour change shown in Fig.6 (a). This indicates the formation of Low temperature hot corrosion at this region of the blade. At the region close to the root of the blade, the temperature is normally lower than the temperature of the other parts of turbine blade during operation and therefore, these regions could be prone to be affected by Low temperature hot corrosion (LTHC). Previous researchers have confirmed from their studies that the low temperature hot corrosion (LTHC) was more effective in the region close to the root of the

Based on the visual observation and material verification, it was concluded that there was a formation of sulphidation on the Turbine blade surface. Sulphidation is an important contributing factor to the failure of turbine blades especially in the turbines operating in marine environment. Fig.4(c) depicts the pressure side of the blade which shows the damage due to hot corrosion. It was more severe near the trailing edge. The sulfur from the fuel might have reacted with the protective oxide layer attacking the base impurities, resulted in the formation of slag called

From the Fig. 4(b) it was observed that there was loss of some material and thickness as well, at the tip of the turbine blade which is attributed to the combined mechanisms such as hot corrosion and fatigue etc. It was further observed that there was a presence of green coloration at the tip of the blade. Some studies have reported that the greenish colour is a macroscopic feature of High temperature hot corrosion (HTHC) [26]. In another study, it was confirmed that HTHC occurs away from the edges and with increasing height from the base (root) of the blade, the extent of this type of corrosion increased [25].

liquid sodium sulfate ( $\text{Na}_2\text{SO}_4$ ). Under this slag, protective oxide layer might be broken down, permitting the attack of parent blade material and causing very severe damage. This mechanism of sulphidation will rapidly damage the base material and results in loss of material. The loss of material could shift natural frequencies into dangerous regions causing the blade to vibrate with much higher amplitudes (resonance) and thus leads to high cycle fatigue and resulted in the reduction in blade life time [20].

Fig.6 (a). Rough surface of the blade at the root, (b). Surface of the blade near its tip which shows some green coloration, (c). Pressure side of the blade showing the damage due to hot corrosion.

At the tip of the turbine blade, it was observed that there was loss of some material and reduction in thickness. This indicates that the

blade tip might have been subjected to the combined mechanisms of hot corrosion and fatigue. Also observed number of rubbing and scrubbing marks on the pressure side surface of the blade. It was further noticed that the turbine blades were subjected to erosion by some particulate matter. The source of this particulate matter might be from the compressor casing during the compression process or protective coating materials used in the combustor. Finally, it was concluded that the turbine blade failure of gas turbine used for marine application was caused by multiple failure mechanisms such hot corrosion & erosion and fatigue. The Hot corrosion reduced the thickness of the blade material and thus weakened the blade. This reduction of blade thickness reduced the fatigue strength of the blade which finally led to the failure of the turbine blade.

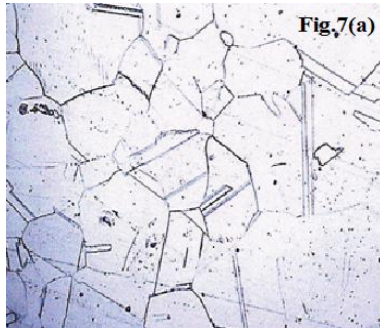
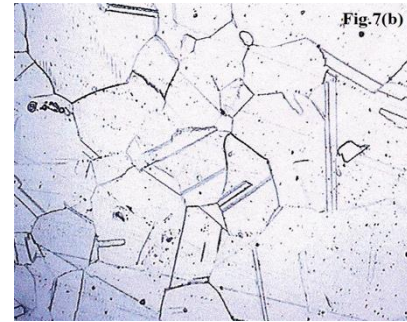
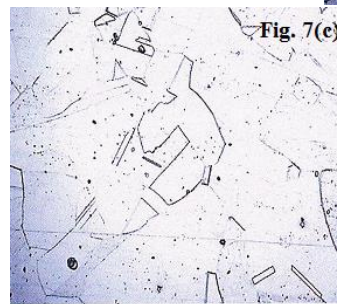
**Fig 7. Micro-structure of turbine blade (a) at the root. (b) at the mid span and (c) at the tip of blade**

It has been observed that the micro-structure at the root of the blade consisting of equiaxed grains of nickel solid solution with grain size of approximately 3-4. Dispersed carbide particles were found in the grain boundaries of the matrix. In general, this type of micro-structure is common for Nickel-Based super alloys. The root of the blade was considered as cold zone which normally does not suffer considerable changes in its micro-structure. This type of micro-structure indicates that the root material of the blade was not exposed to the high temperatures. A similar micro-structure was found at the mid span (air foil) region of the blade material, which indicates that this part of the blade material was also not subjected to overheating i.e. this is the region, normally subjected to the highest temperature of the blade but in this application, the temperatures might be controlled and were well within the permissible limits and the micro-structure was not affected by blade operation at higher temperature. Samples for micro structural evaluation were also taken from the tip of the blade material. The micro-structure shows the carbides and gamma

prime phases. In this, the carbides were decorating the grain boundaries. This micro-structure was almost similar to that of root and mid span of the blade. It emphasizes that there was no evidence of micro structural damage noticed due to operation of a blade at elevated temperatures. These results indicate that the turbine blades of gas turbine engines used for marine applications were operated in normal operating temperature conditions. From these results it was understood that, there was no failure noticed in the gas turbine blade under examination due to blade operation at high temperatures which might be within the limits.

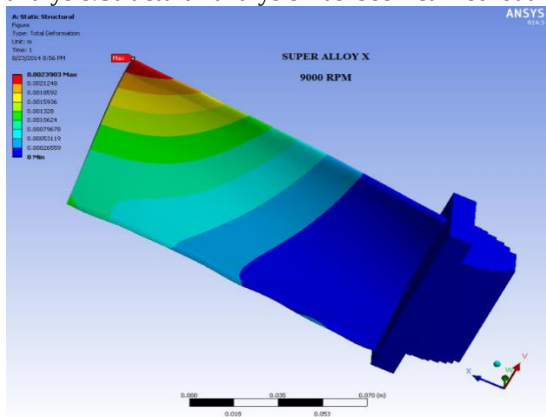
Fig 8.1 : Deformation of the turbine blade due to gas pressure and combined loading.

Fig. 8.1 shows deformation produced in the turbine blade due to action of all forces such as gas and centrifugal forces. It is observed that the maximum deformation of 0.00239 m occurs at the tip section of turbine blade material and the minimum occurs at the root section. There was no evidence of rubbing between tip of the turbine blade and casing, indicating that the elongation is within the limit.

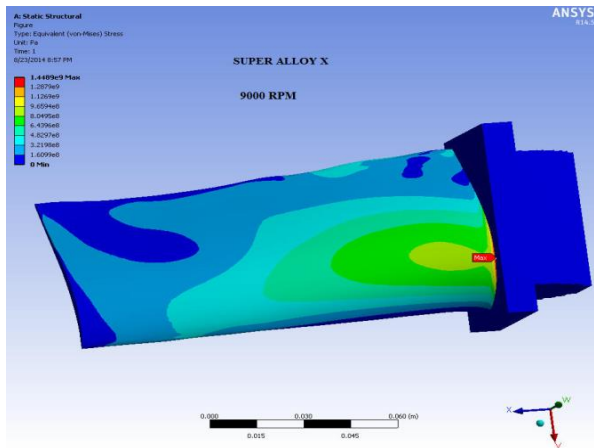
Fig 8.2 : Stress Distribution in the turbine blade due to gas pressure and combined loading

Fig. 8.2 shows the stress distribution in the turbine blade due to action of all forces such as gas and centrifugal forces. It is observed that the maximum stress of 965 N/mm<sup>2</sup> occurs at the root section and on the pressure side of gas turbine blade which is within the yield strength of the material. Minimum stress occurs at the tip of the turbine blade section.

Maximum stresses and strains are observed near the root of the turbine blade and upper surface along the blade roots. The maximum stress of 965 N/mm<sup>2</sup> occurs at the trailing edge nearer to the root of the blade exceeds the yield stress of the material and this might lead to the failure of the turbine blade. At all other parts of turbine blade, the stresses induced are within the same limits.

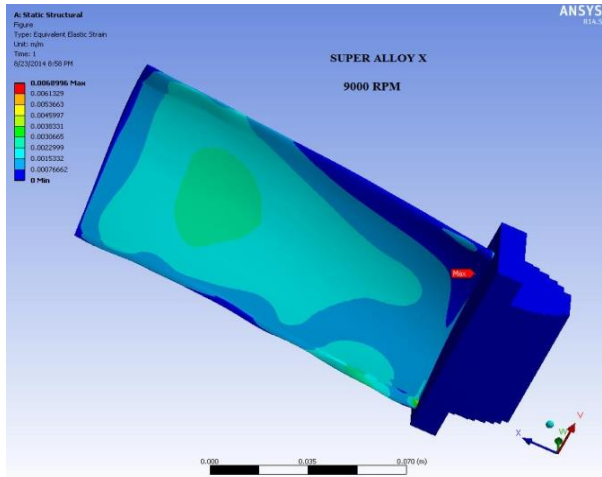
Fig 8.3 shows the Strain distribution in the HPT turbine blade due to action of all forces such as gas and centrifugal forces. It is observed that the maximum strain of 0.0053m/m occurs at the root section and on the pressure side of gas turbine blade. Minimum strain occurs at the tip section of the turbine blade section.

**Fig 8.3 : Strain distribution in the turbine blade due to gas pressure and combined loading.**

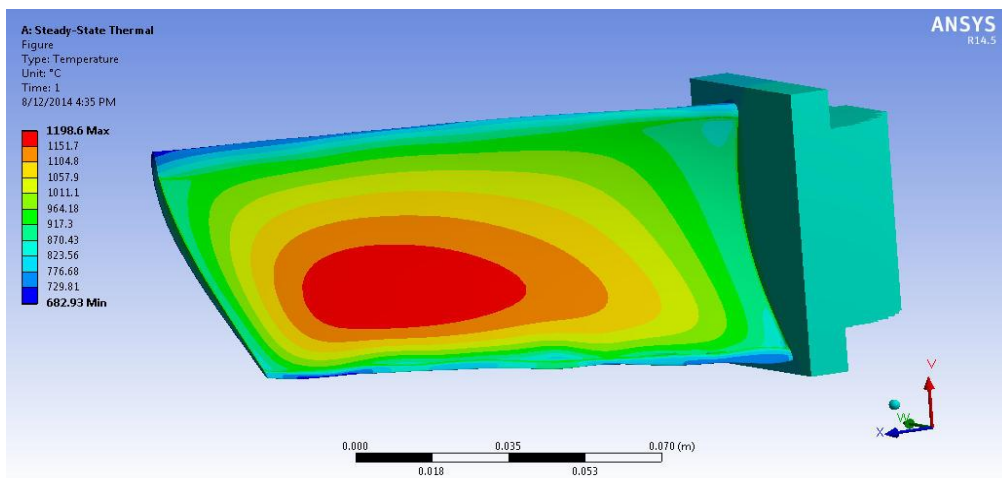
**Fig 8.4: Temperature distribution in the turbine blade.**

Fig 8.4 shows the Temperature distribution in the turbine blade made of Nickel based superalloy-X due to temperature gradient and heat flux. It has been observed that maximum temperature of 1198.6 °C occurred near the tip section and minimum temperature occurred at the root of the turbine blade. The maximum temperature induced in the turbine blade is well within its melting temperatures of the turbine blade material.
