## PROBABILISTIC AND DIAGNOSTIC METHODS TO DETERMINE THE MULTIPLE FAILURE MECHANISMS OF HPT 1<sup>ST</sup> STAGE MARINE GAS TURBINE BLADE.

The failure analysis of high pressure turbine (HPT) blade belonging to 30 MW gas turbine used in marine applications is presented. Before failure, the turbine blade under evaluation was operated for about 10000 hours while its service life was expected to be around 15000 hours. The gas turbine blade was made of Nickel based super alloy and was manufactured by investment casting method. An attempt has been made to analyze the causes and modes of failure of a gas turbine blade. During operation, the turbine blade is subjected to large centrifugal forces and operated at elevated temperatures in corrosive environmental attack such as oxidation, hot corrosion and sulphidation etc. The investigation includes the activities like visual inspection, determination of material composition, microscopic examination, metallurgical analysis and Mechanical analysis. Metallurgical examination was carried out to diagnose the possible causes of blade failure of micro structural damage due to blade operation at elevated temperatures. The thermal-structural finite

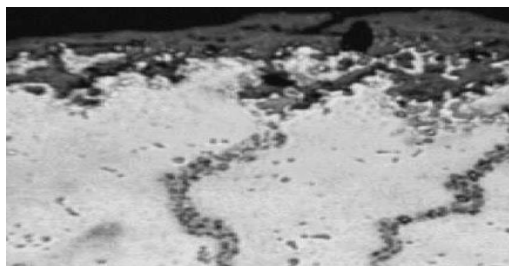
Hot corrosion on turbine blades can be intensified by the presence of vanadium, which produces  $\text{V}_2\text{O}_5$ , in combination with the alkalis, while in molten state, can aggressively dissolve metal oxides. High temperature hot corrosion also known as Type I corrosion, which occurs in the approximate temperature range of  $825^\circ\text{C}$  to  $950^\circ\text{C}$  [20]. Fig 1 shows the micro structure of the surface of the blade material near the tip which has suffered from the hot corrosion.

Fig.1. Type I hot corrosion, grain boundary diffusion

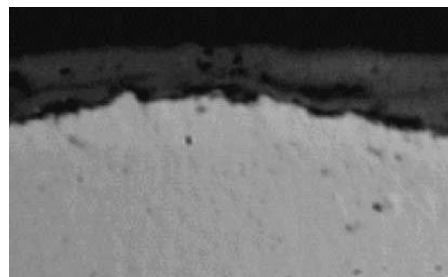
Low temperature hot corrosion (LTHC) also known as Type II hot corrosion which occurs during the approximate temperature range of  $700^\circ\text{C}$  to  $800^\circ\text{C}$ . From the Fig.2, it is noticed that the pitting attack is typically nonuniform with layered type corrosion scales. No intergranular attack is found in the base metal. Very little sulphide formation within the metal is observed. Fig 2 shows the micro structure of the surface of the blade material close to the root of the blade with no grain diffusion but suffered from Low temperature hot corrosion (LTHC). In both types of hot corrosion, there is a breakdown in the protective oxide layer scale aided by thermal cycling [20].

Fig. 2. Type II hot corrosion, no grain boundary diffusion
